Question of the Week: What Are the Risks for 40-60 Year-Old Facilities?

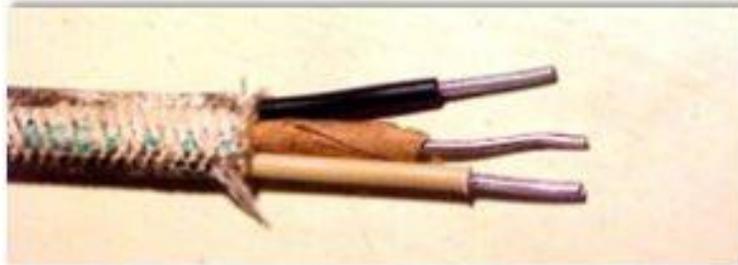
Electrical Systems

1. Aluminum wiring – associated with fires due to aluminum's tendency to short circuit necessary connections. There have been a series of industry solutions involved with changing out outlet devices to deal with difficulty in maintaining connections. Now, at 50 years old, aluminum

wiring is reaching the end of the EUL of electrical wiring. Copper wiring has been used, almost exclusively, since the 1980's.

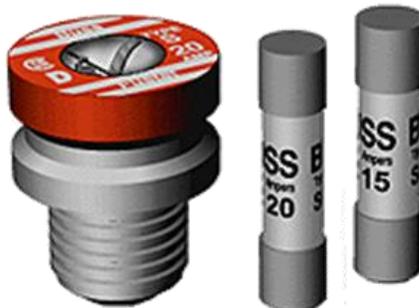
Fuses

2. Federal Pacific Electric – Stab Loc Panels – associated with unreliable breaker switches. Federal Pacific electric panels circumvented Underwriter Laboratory approvals. Replacement parts are no longer made.
3. Fuse Panels – Although fuse panels were introduced before 1970's they were continued to be used in the 1970s. In residential application, fuses required fitting with a non-tamp sleeve to keep tenants from installing pennies to over-ride faulty fuses. Fuse panels were frowned upon by lenders, especially without tamper-proof fuses.

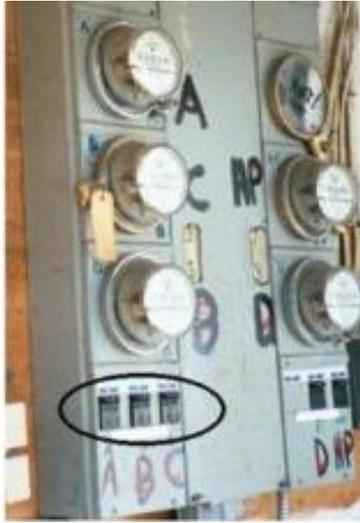
4. 60 Amp minimum – Residential main fuses were common in the mid-20th century for residential application for apartments with gas-fire equipment. Lenders frowned on this amount of electrical service after increasing use of electrical appliances, laundry equipment, and modern electrical devices. Lenders have required close attention to electrical capacity for fuses and circuit breaker switches.

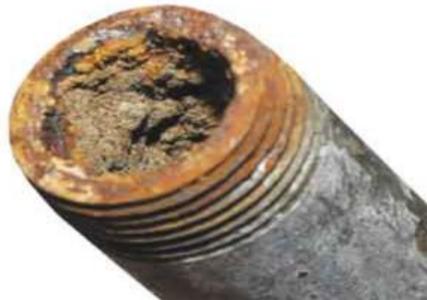
1. Galvanized plumbing was used throughout the early part of the 20th century and was still being used in the 1970's. Copper piping has been preferable for many decades, along with CPVC and PEX piping in recent decades. Galvanized piping corrodes prematurely at joints and is susceptible to mineral build-up in hard water conditions. Galvanized piping has tended to last just 40 years while copper will typically last 60 years.

Example of galvanized piping
